## **Tarp Canopy Over The Paper Machine Wet End To Prevent Condensation Drippage Onto The Machine Of No. 6 Paper Machine In Naheola Alabama**

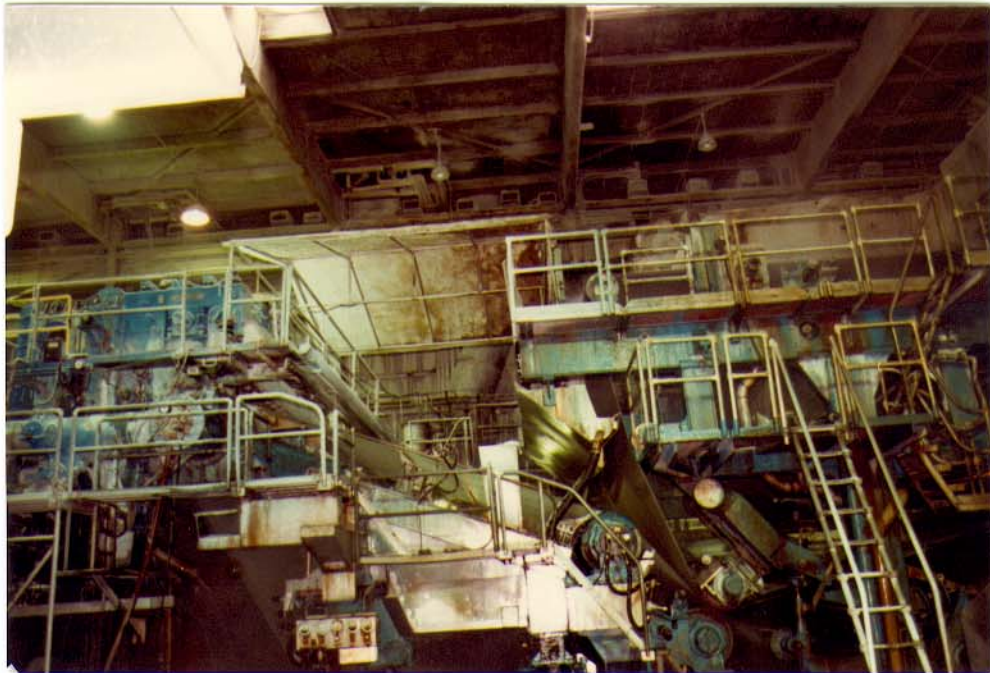
This paper machine building had roof condensation and corrosion problems for many years which is why the tarp in this picture was hung over the forming section of the machine. The building and paper machine was installed in 1966 and in 1987 the roof was replaced. Then in 1990 the roof was replaced again along with four of the box girders over the machine that had too much deflection. The cost of the 1990 replacement was \$1,300,000 for a 20,328 ft<sup>2</sup> roof.
